The Refurbishment of Shafts by Thermal Spray Coating**Technical Bulletin Ver. 1****Revision: March 2013**

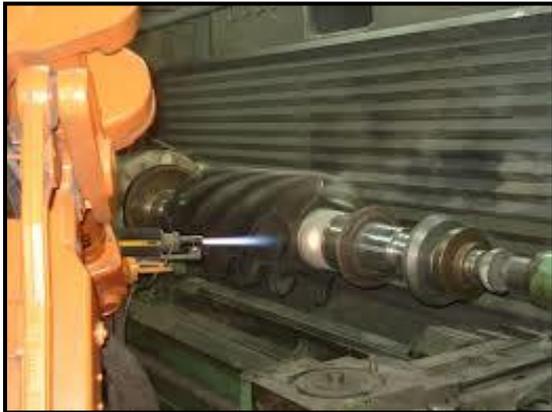
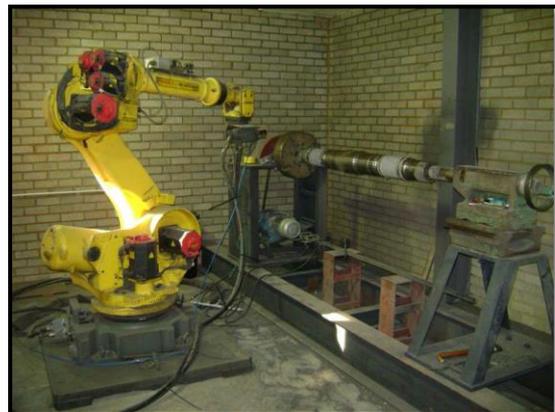
Shafts are sprayed in our large top-loading spray booth, where we can handle rods up to 5,500 mm in length and up to 6,000kg in weight.

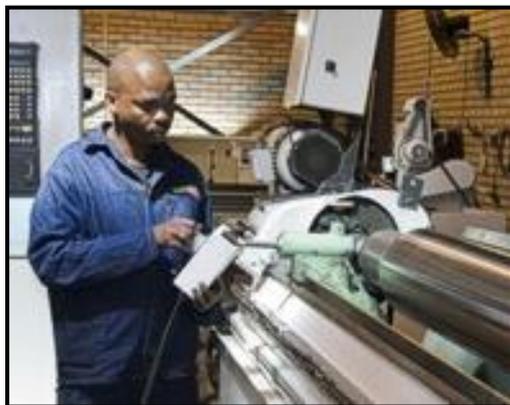
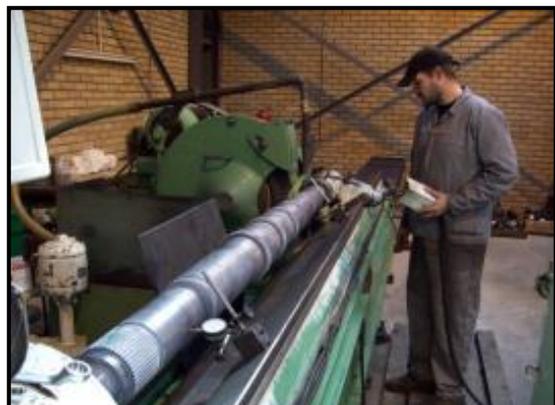
The grinding of the shafts is done in our grinding workshop, where we have several large cylindrical grinding machines (maximum 3800 mm between centres, maximum 700 mm swing), all fitted with diamond wheel grinding capability. For specific surface finishes we have two dedicated finishing lathes for the polishing and/or superfinishing of shafts.
